Datum/Date:
10/2003
Update: 12/2003
Update: 04/2004

41 03 03 (025)

Fractures on rear-axle support E46

E46

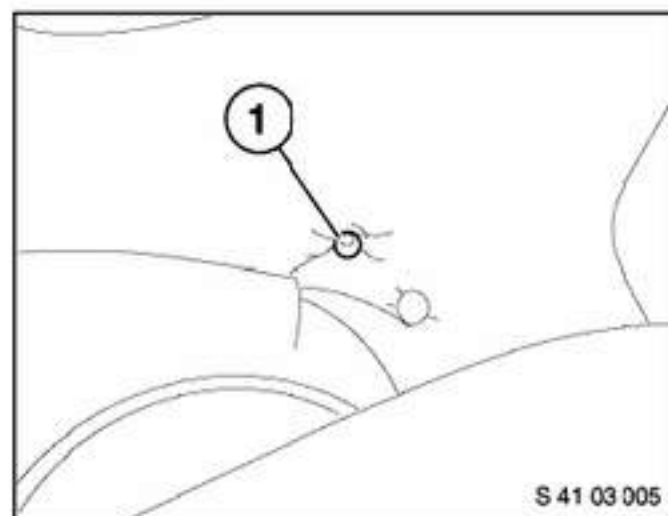
Figure 1

Fractures may be caused by extreme loads due to strong load shifts, especially in operation in diving schools, trailer towing, an extreme sporty driving style or if non-approved sport suspension systems are installed.

1. Position vehicle on lifting platform.
2. Check the area of the rear left rear-axle support for fractures. Fractures may emanate from welding points (please refer to figure 1).
If no fractures can be found, continue troubleshooting or the inspection.

- Install the repair part. Please refer to Repair Instructions "Replacing rear-axle support", RA 41 11 400
- Adjust the rear axle
- Perform wheel alignment

7. If fractures smaller than 20 mm are found, or after the repair part has been fitted, fill the rear-axle member with foam in the area of the rear left rear-axle support.
